# Safety Inspection Report

Annual Inspection

## Helmdon Play Area

Helmdon Parish Council

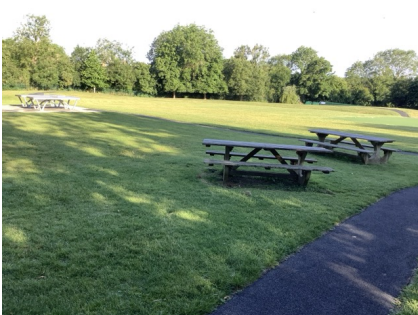
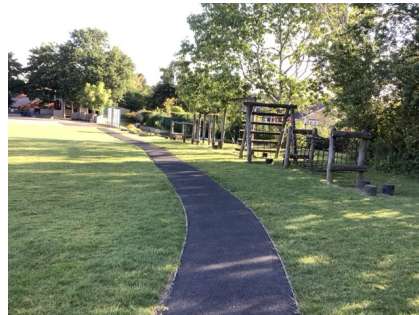
Item was not inspected on this occasion.

There are several items on site that the parish council have instructed our inspector not to inspect as the equipment belongs to the school and should be inspected by them. However the equipment will be accessible to anyone who accesses the park.

Read the notes for further action.

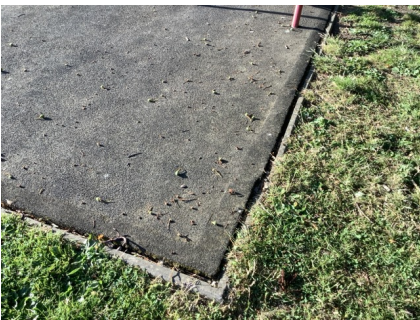
Shrinkage / separation of the surface. This may give a trip hazard.

Low

6

Re-glue and fill gaps and joints as necessary.

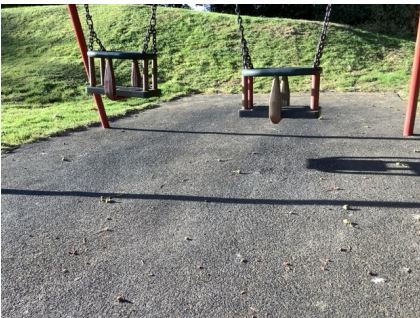
Seat(s) set at incorrect height.

One seat set too low. Our inspector recommends both seats are raised to approximately 500 mm to the bottom of the seat.

Medium

8

Adjust to give a minimum of 350 mm clearance for standard seats, and 400 mm for tyres, baskets and other groups seats.

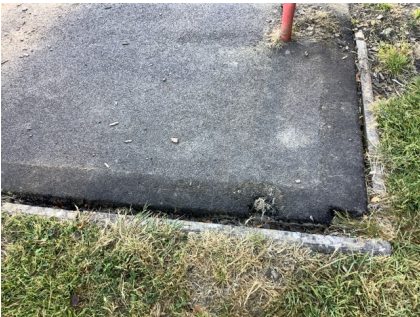
Shrinkage / separation of the surface. This may give a trip hazard.

Edges opening up and small section is damaged.

Medium

8

Re-glue and fill gaps and joints as necessary.

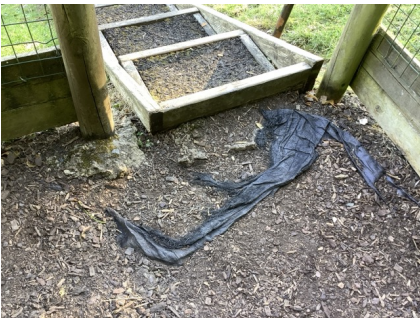
Loose fill levels are too low to provide adequate protection.

Bark is low exposing the lining and concrete foundation. Top-up.

Medium

9

Rake and fork over and top up as required to maintain minimum depth (usually 300 mm).

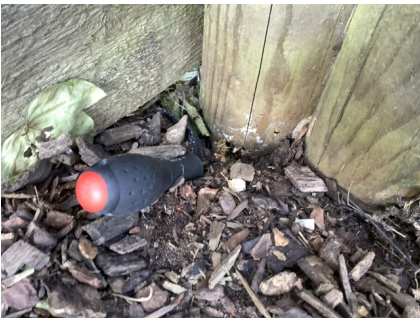
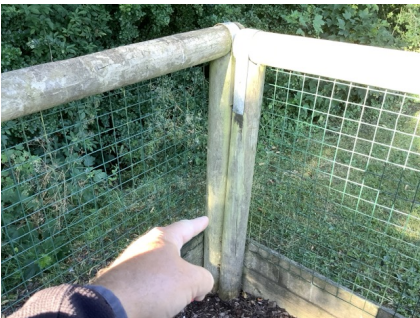
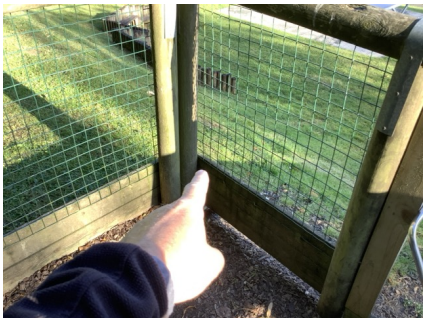
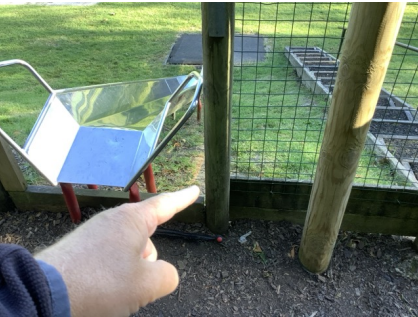
Timber is decayed.

Three fence posts decaying.

Medium

8

Replace affected parts.

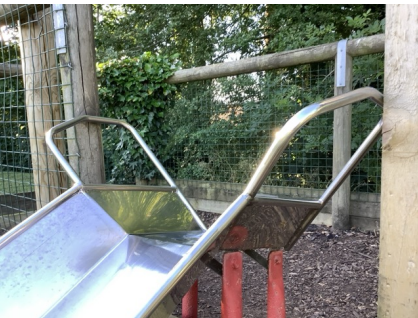
There is a head entrapment.

In the top slide hand rails.

Low

6

Refer to manufacturer for comment.

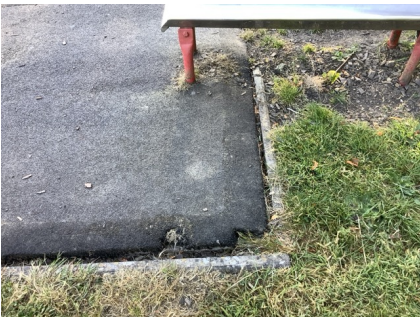
The safer surface has hard edging / foundation within the impact area.

Edging is within the falling space.

Medium

9

Modify to remove the hazard.

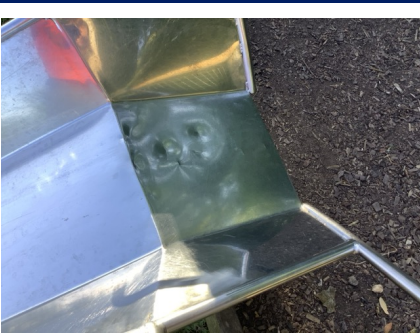
The starting section of the slide is less than the minimum permitted length of 350 mm.

Low

7

Refer to manufacturer for comment.

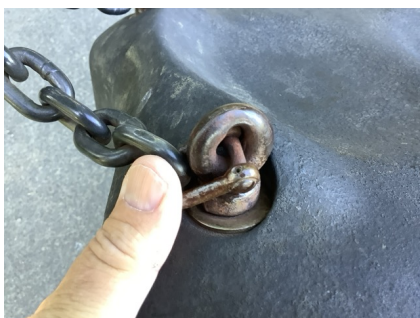
Chain link connectors worn.

Seat shackle bolts wearing. Replace.

Replace worn parts.

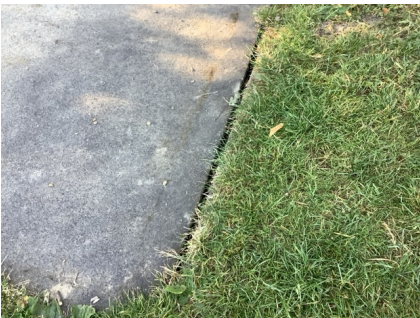
Shrinkage / separation of the surface. This may give a trip hazard.

Low

7

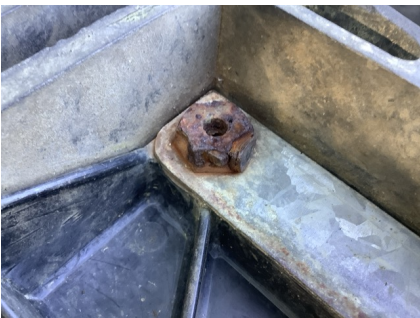
Fittings are rusty.

Seat nuts rusting. Replace.

Low

7

Replace.

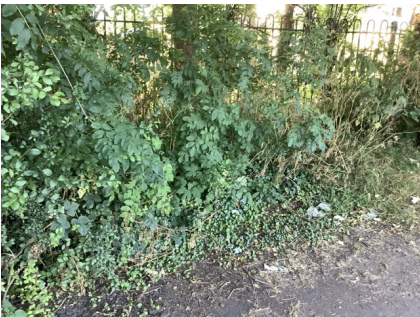
Encroaching vegetation or trees.

Medium

8

Remove.

Trim back all vegetation beyond the surfacing area by 500 mm.

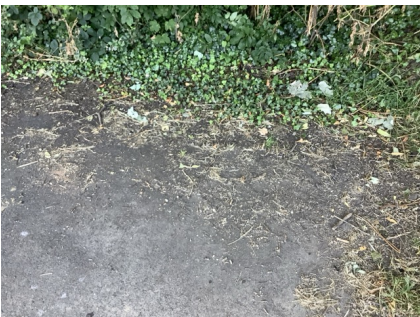
Debris on surface.

Medium

9

Sweep away debris on a routine basis.

Clean debris off the surface underneath the trees.

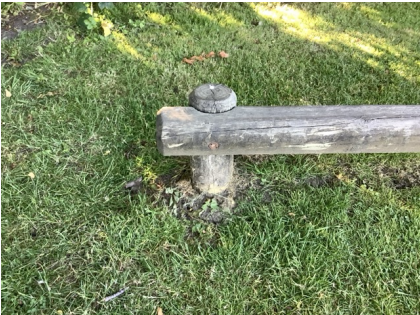
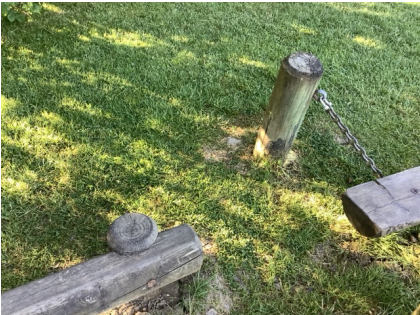
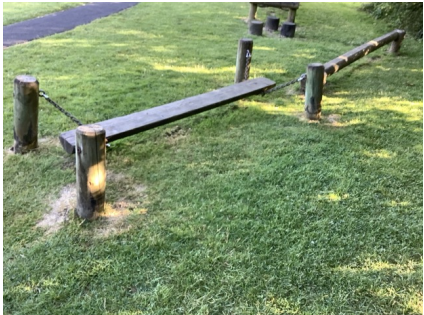
The supports are loose in the ground.

Several foundation blocks are loose in the ground.

Risk level:  
 Medium

Risk score:  
 8

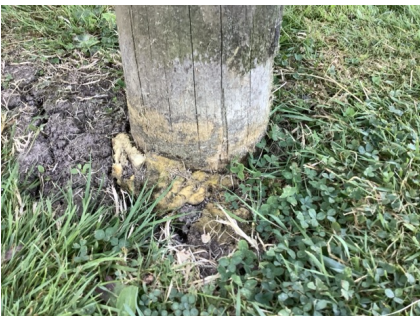
Strimmer damage is present on posts, allowing water to enter and timbers to soften. It can also remove the protective envelope around the timber. Prevent further damage and check timbers for decay throughout the year.

Risk level:  
 Medium

Risk score:  
 9

Prevent further damage.

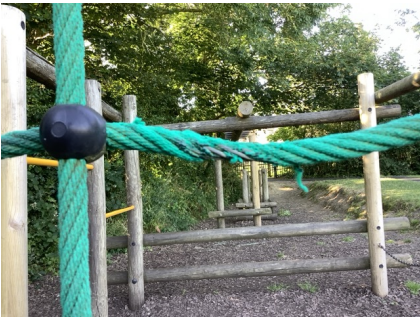
Wire is exposed.

Rope wire exposed. Monitor and replace if wires become broken.

Low

6

Read the notes for further action.

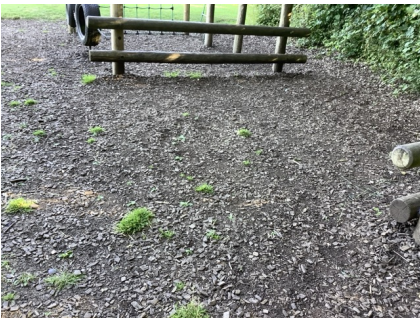
Surface is compacted or displaced.

Medium

8

Rake and fork over and top up as required to maintain minimum depth (usually 300 mm).

Remove grass growing Inside the area and top up levels.

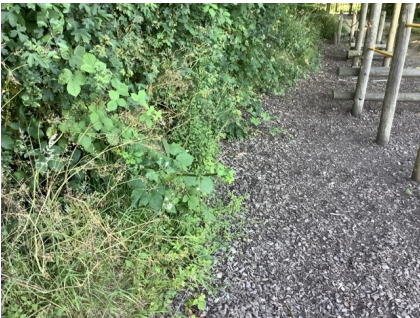
Encroaching vegetation or trees.

Medium

8

Remove.

Trim back brambles and branches to approximately 2.5 m above the unit/ground and 2 m to the side of the unit.

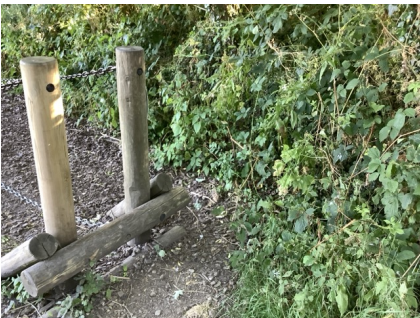
Encroaching vegetation or trees.

Medium

8

Remove.

Trim back weeds and branches to approximately 2.5 m above the unit/ground and 2 m to the side of the unit.

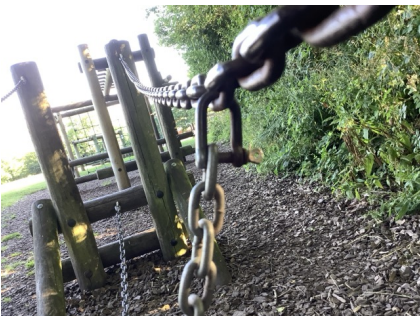
Butterfly shackles have been used, presenting non-rounded edges.

Low

6

It is recommended that an alternative type of shackle that does not have sharp ends be used. Use fixings compliant with EN 1176.
